Debris/Ice/TPS Assessment And Photographic Analysis For Shuttle Mission STS-31R

Charles G. Stevenson
NASA/Kennedy Space Center

DEBRIS/ICE/TPS ASSESSMENT
AND
PHOTOGRAPHIC ANALYSIS
OF
SHUTTLE MISSION STS-31R

April 24, 1990

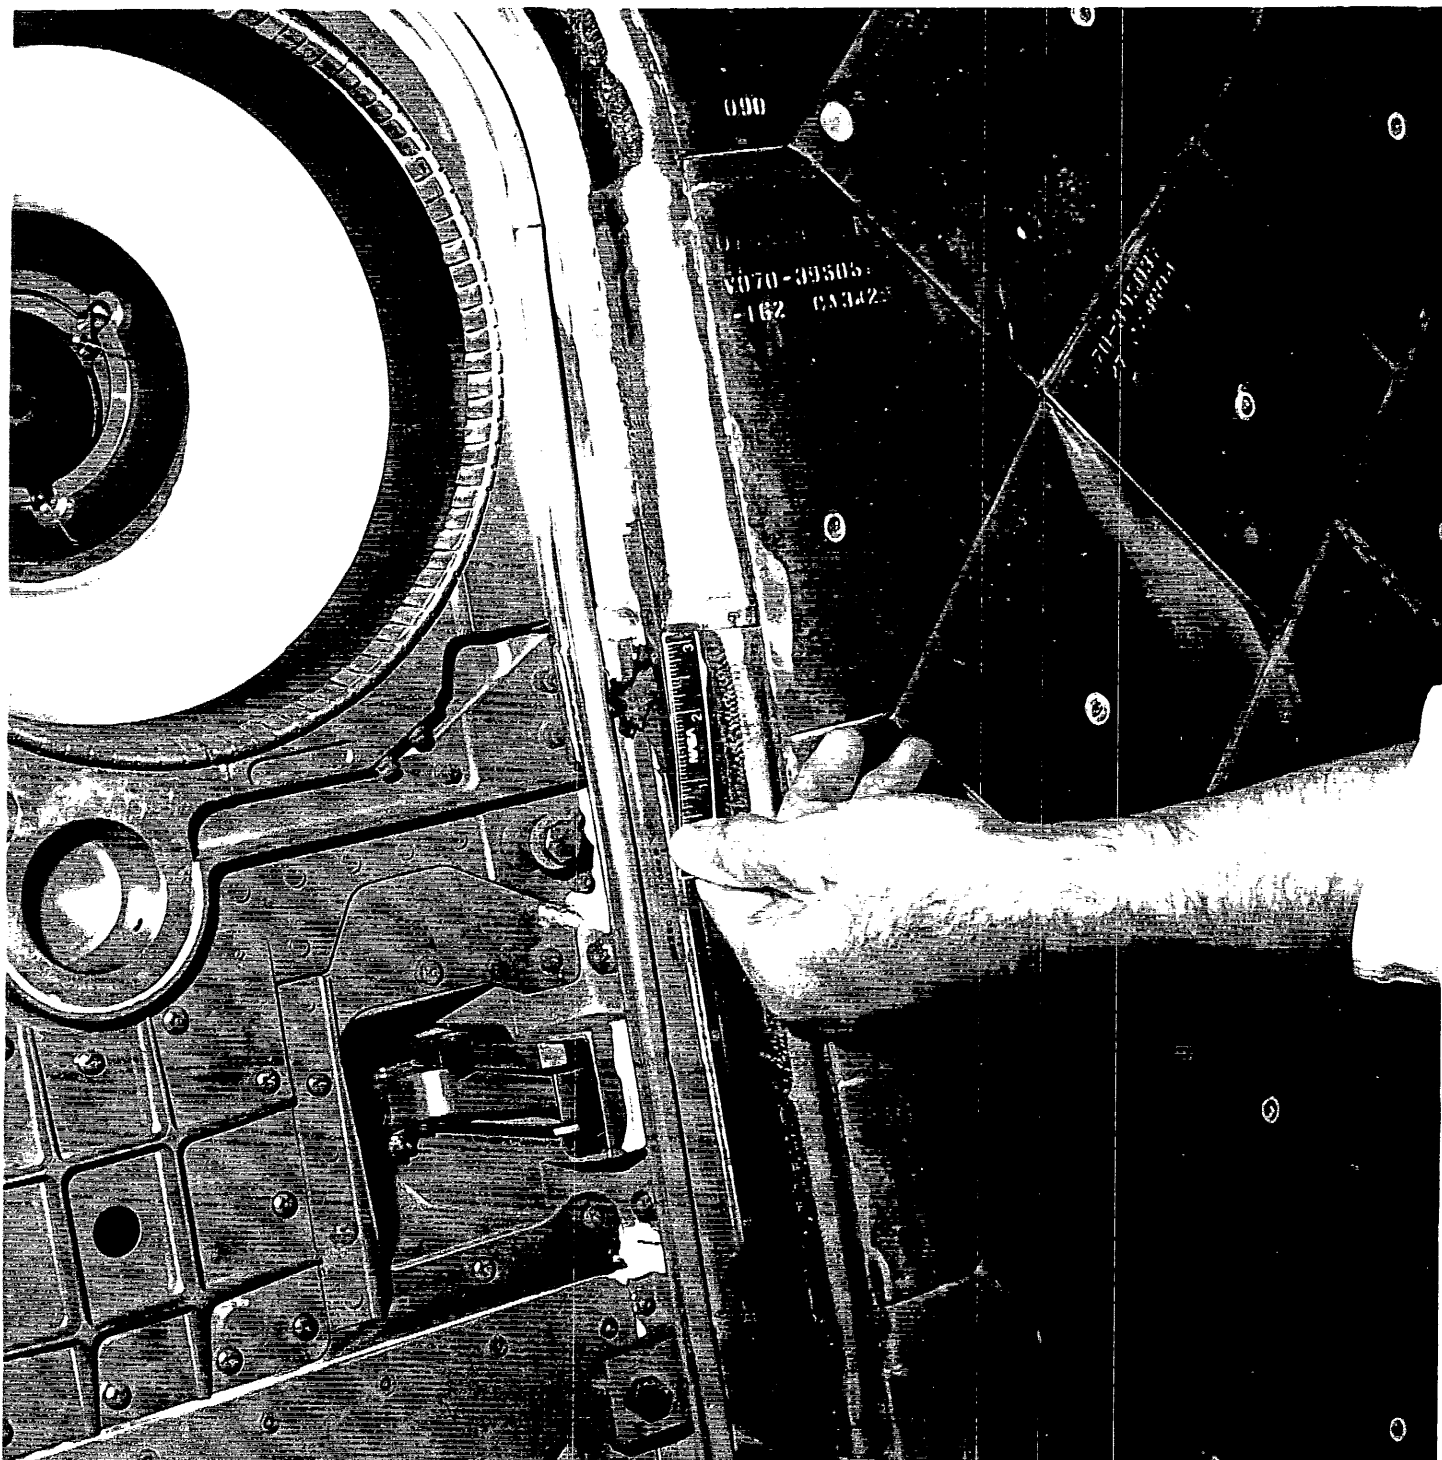
Brown/black-colored foreign material was removed from the LH2
ET/ORB umbilical for laboratory analysis

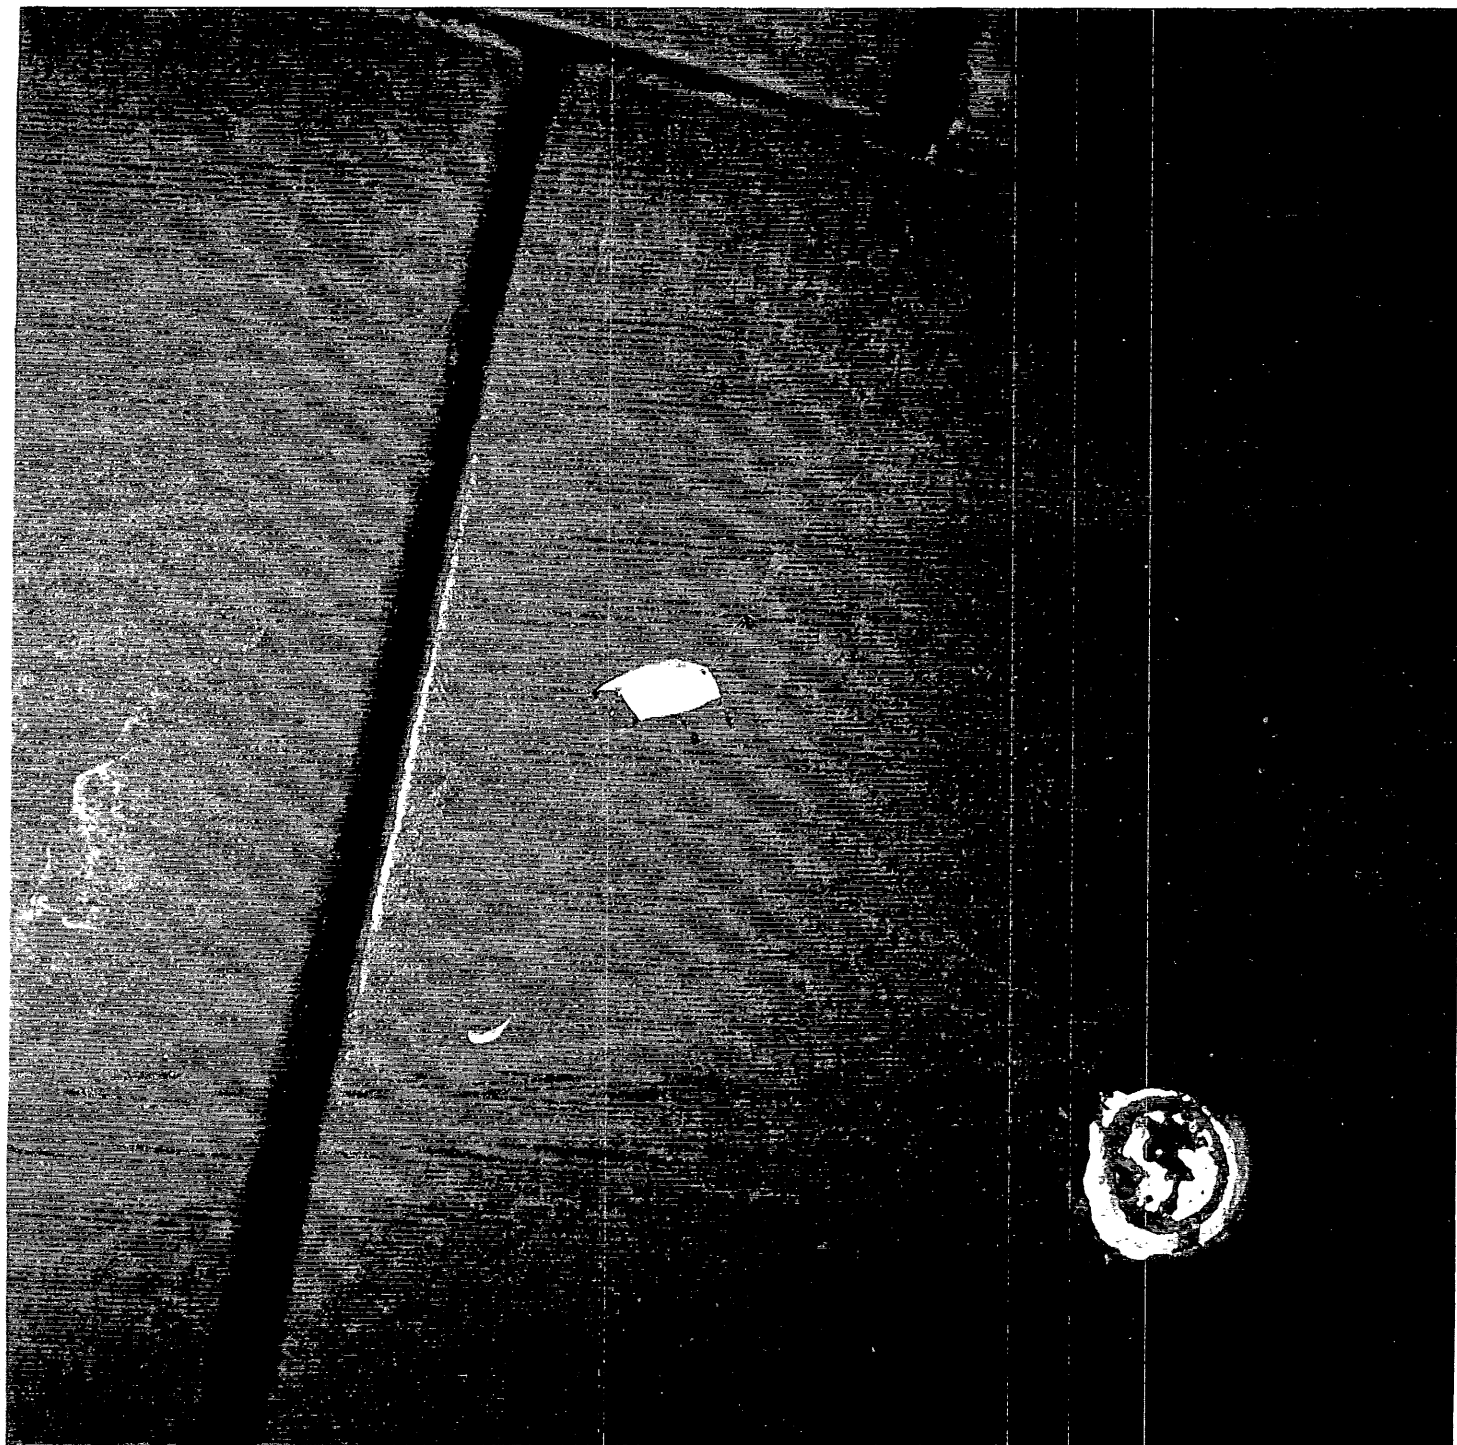
Analysis of dark residue in tile damage site cavity
revealed tile material and landing site products

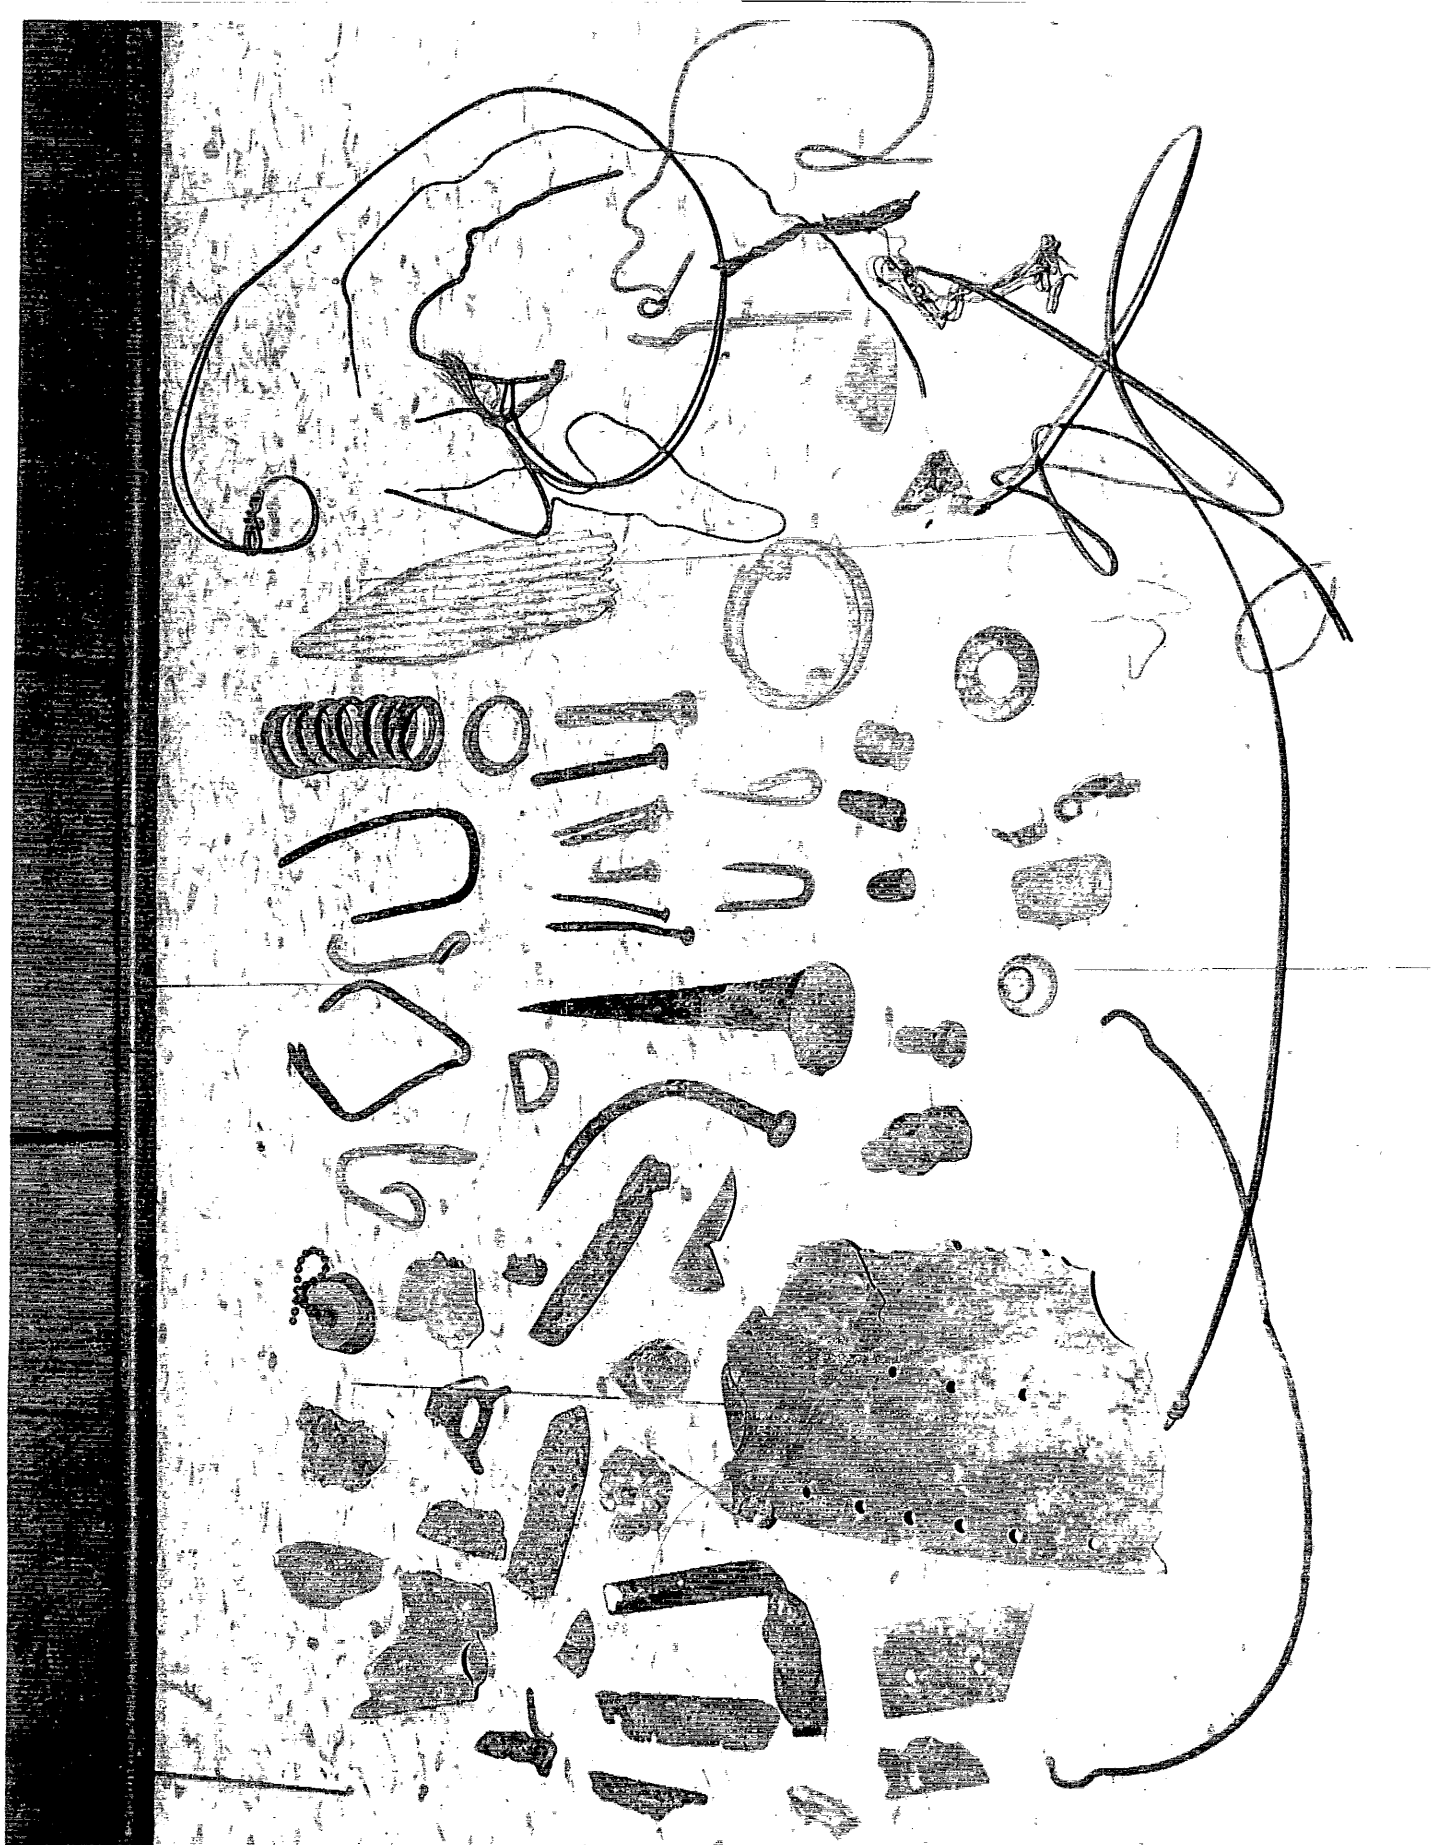
Debris collected during pre-landing runway walkdown
